## **ANNUAL INSPECTION REPORT FOR PETERSTON SUPER ELY PLAYING FIELD**

Fford-yr-Eglwys, Peterston Super Ely, Vale of Glamorgan

21/7/2026

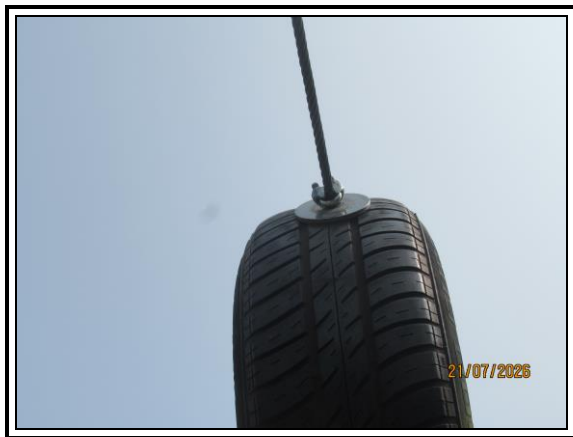
| <u>Item/Make</u> | <u>Compliance/Condition</u> | <u>Surface</u> |
|---|---|---|
| 2. Hags<br>Cableway<br><b>Medium Risk: 10</b> | Remove cable clips from leading side of tyre stop (shock on cable when traveller impacts) | Green Artificial Turf<br>Satisfactory |

(Cable clip at tyre stop on cableway)

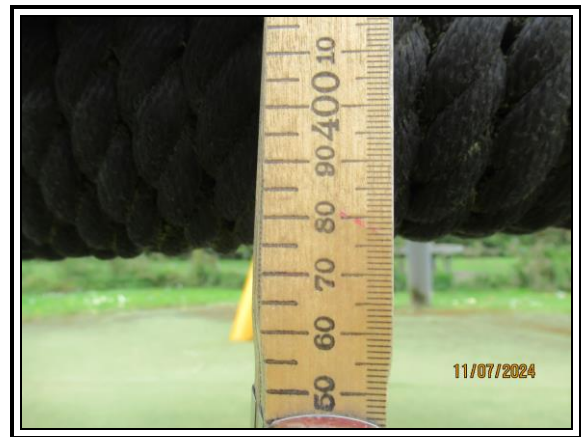
| <u>Item/Make</u> | <u>Compliance/Condition</u> | <u>Surface</u> |
|---|---|---|
| 3. Hags<br>Group Swing<br><b>Medium Risk: 10</b> | BS EN 1176-2, Sec. 4.2, seat too low (actually 375mm above surface, should be at least 400mm from underside of rigid part of seat in its most onerous position) – requires attention<br>Replace worn rapid links at seat end of chains <b><u>A.S.A.P.</u></b> | Green Artificial Turf<br>Satisfactory |

(Group seat at swing 375mm above surface – library photo)

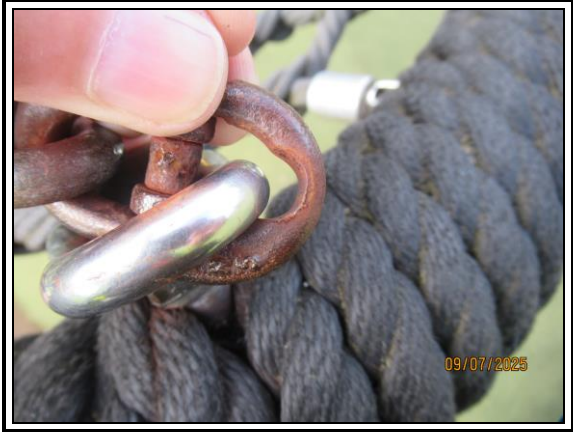
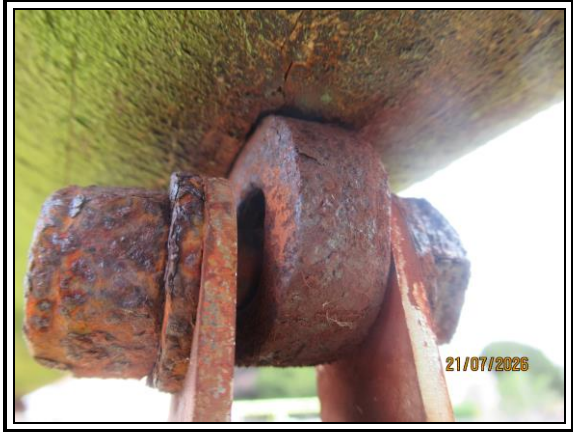
| Item/Make | Compliance/Condition | Surface |
|---|---|---|
| | (Worn rapid link on chain at group swing – library photo) | |

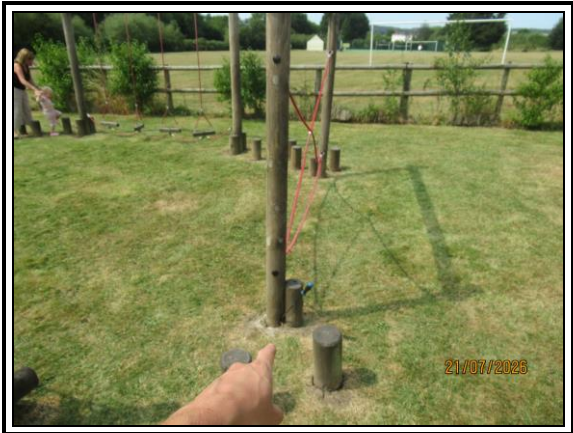
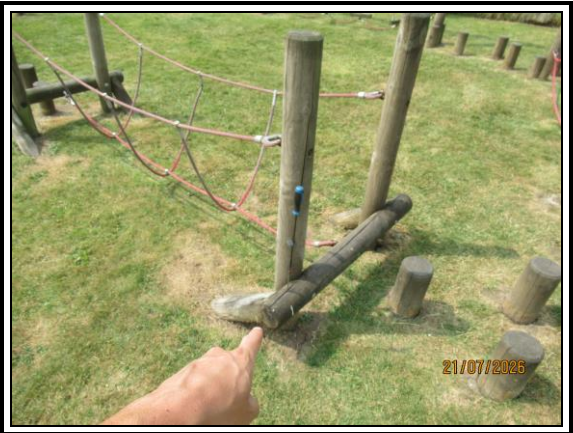
| <u>Item/Make</u> | <u>Compliance/Condition</u> | <u>Surface</u> |
|---|---|---|
| 5. Unknown Make<br>Nine-item Trim Trail<br><b>Medium Risk: 12</b> | Splits in logs – <u>monitor</u><br>Cross ropes showing signs of wear – <u>monitor</u><br>Fit bushes in bearing fixings on log traverse as fixings worn<br>Cross ropes support rotten – requires attention <b><u>URGENTLY (as per phone call 21/7/26)</u></b><br>Replace two missing bolt cover caps on supports at cross ropes<br>Replace rotten cross log on rope bridge | Grass<br>Satisfactory |

| Item/Make | Compliance/Condition | Surface |
|---|---|---|
| | (Location of rotten cross ropes support at trim trail) | |

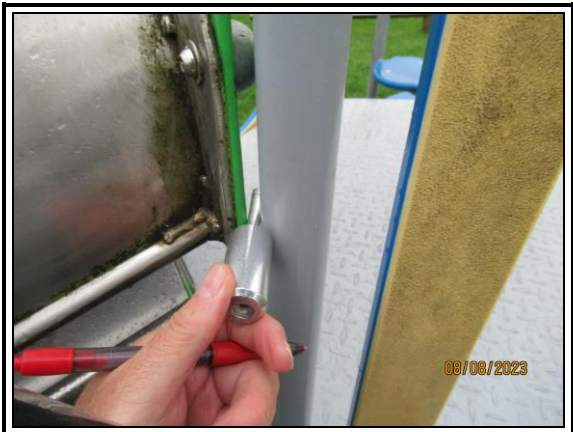
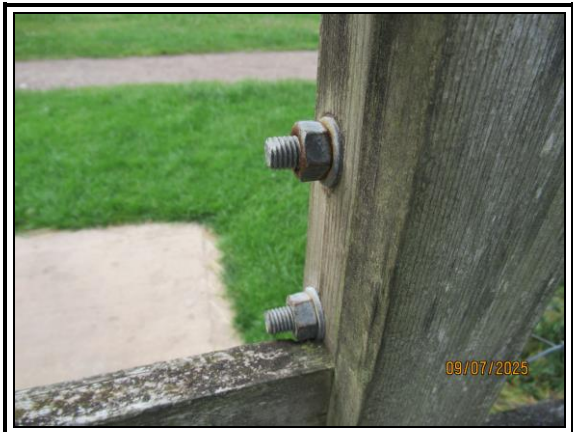
| <u>Item/Make</u> | <u>Compliance/Condition</u> | <u>Surface</u> |
|---|---|---|
| 6. Wicksteed<br>Junior Multi Unit<br><b>Medium Risk: 8</b> | BS EN 1176-1, Sec. 4.2.7.6, potential finger trap between frame & panel on tunnel | Green Artificial Turf<br>Satisfactory |

| Item/Make | Compliance/Condition | Surface |
|---|---|---|
| | (Potential finger trap at junior multi unit – library photo) | |
